Global Advanced Research Journal of Geography and Regional Planning (ISSN: 2315-5018) Vol. 1(5) pp. 088-098, October, 2012  
Available online <http://garj.org/garjgrp/index.htm>  
Copyright © 2012 Global Advanced Research Journals

# Localised Environmental Degradation Due to the Offshoots of Highway Development Projects: The Case of Central Ethiopian High Lands.

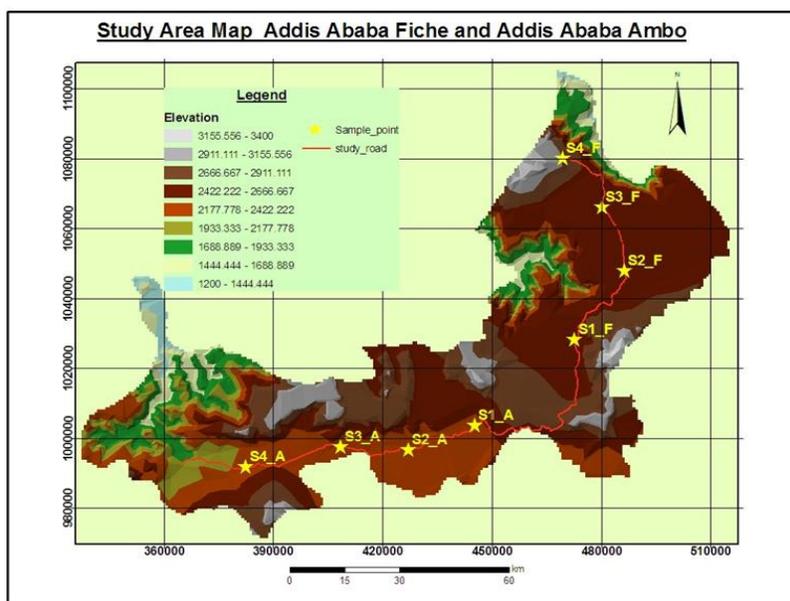
SA=Ambo site, SF=Fiche site),  
**Figure 1.** topography and drainage map of the study area.

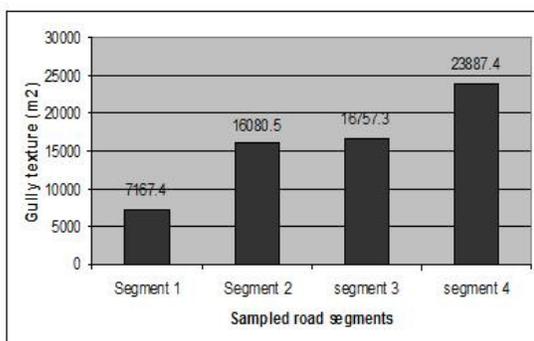
Gully Texture area covered along Fiche road site

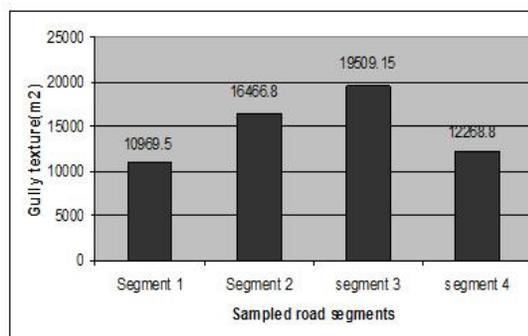
Gully Texture area covered along Ambo road site

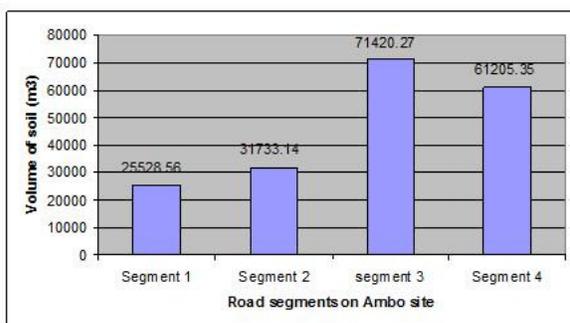
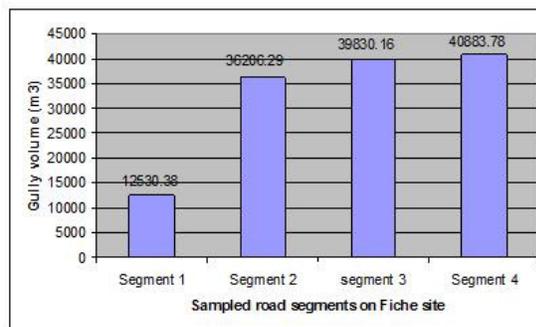
**Figure 2.** Volume of soil lost in the sampled sites

Volume of soil lost in m<sup>3</sup> Fiche site.

Volume of soil lost in m<sup>3</sup> From Ambo site.

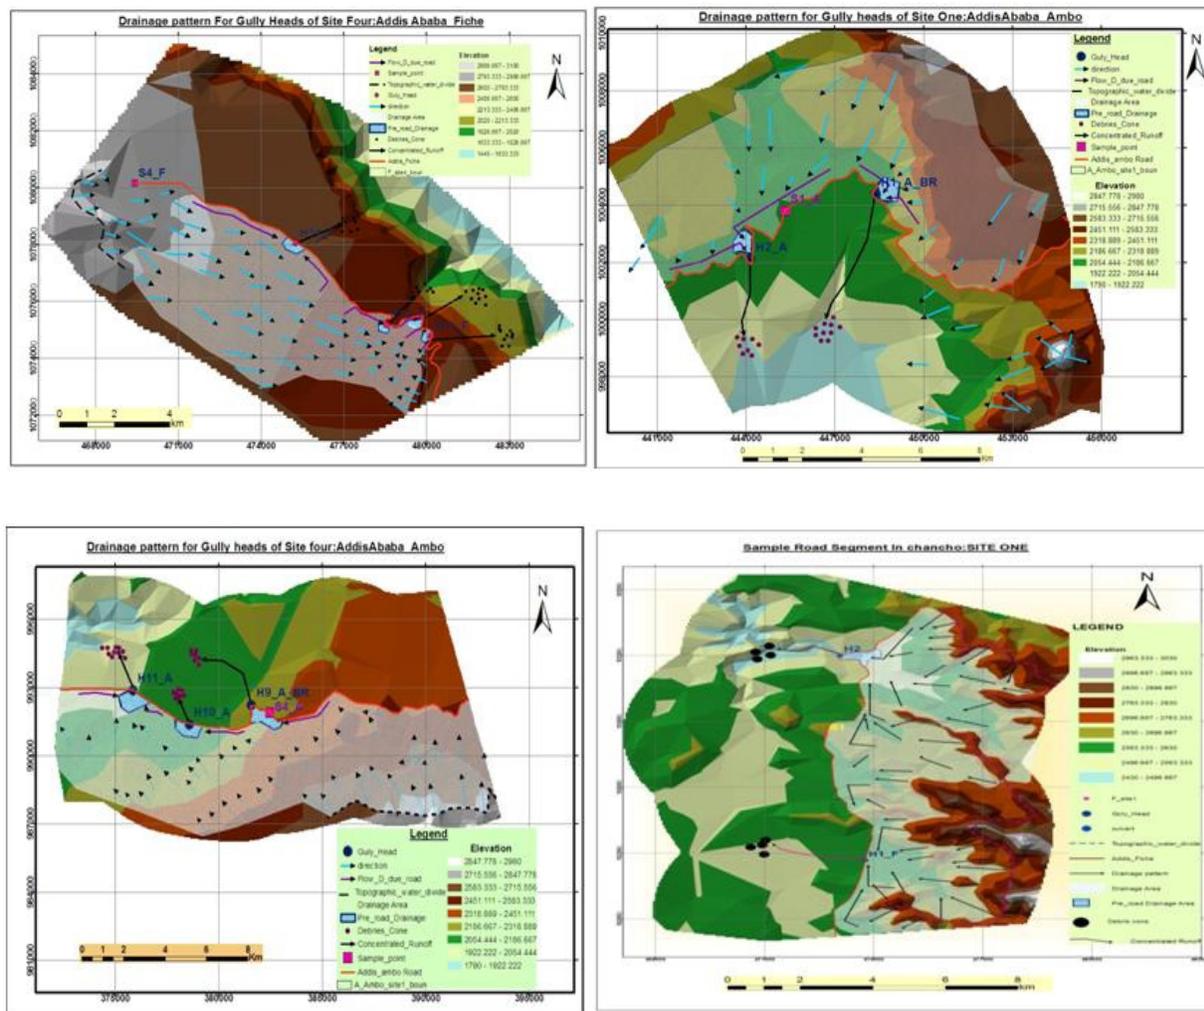
Figure 3. DEM of the sampled road segments
